APD-IM-152

# Adapting Conductance Technology for Military Application

Randy Swanson  
Midtronics, Inc.

June 20, 2005

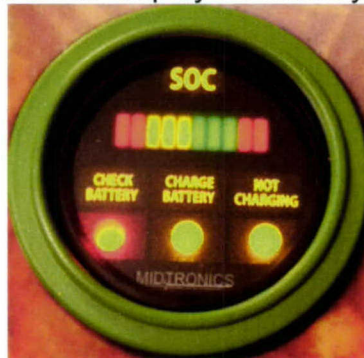
Figure 1: iBMS display for military vehicles

A flashing Not Charging LED may be expected in situations such as silent watch where power is being required but the alternator is not running to provide that power. Note: When the Master Switch is first turned on, the DIM will assume there are no charging problems.

Since inGEN technology can monitor the battery's real-time State of Health and its decline over time, the useful life of the battery can be predicted. The driver's display supplied in the MIL112 version includes LEDs to indicate that batteries are reaching the end of their useful life and LEDs indicating a battery failure, which should be replaced. This will assist the crew in replacing worn or failed batteries in the safety and convenience of the depot or maintenance area instead of possibly becoming stranded on the battlefield.

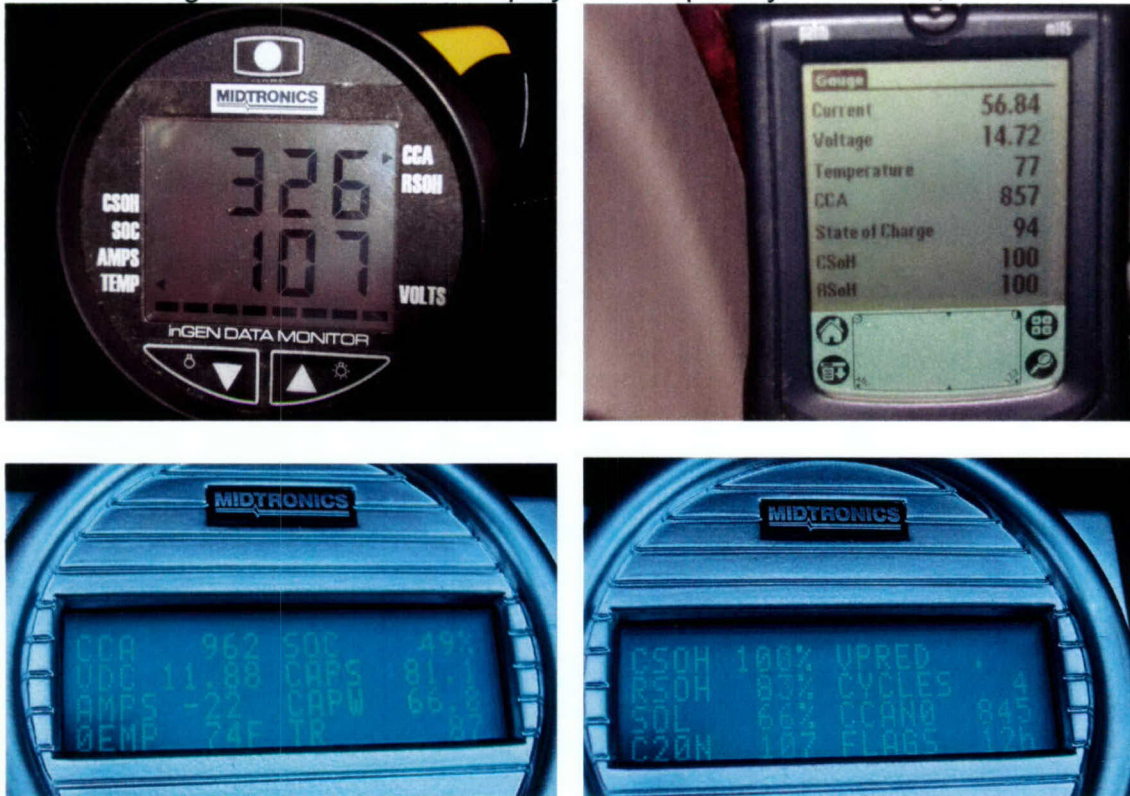
Figure 2: Other iBMS displays developed by Midtronics, Inc.

To prevent operator information overload, Midtronics desires U.S. Army input to determine what information is most useful to them. Midtronics Inc. can arrange the information to be displayed in the user's specified format as demonstrated in Figure 2.
